# Southern California Regional Rail Authority (SCRRA)

### **Performance Audit: Central Maintenance Facility Operations**

**Audit Report No. 2020-03-IA**

**Date: December 30, 2019**

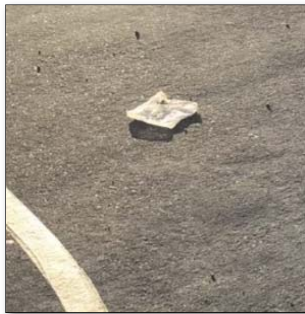
Ex. 6 - Wrapper

Trash in Service Area – We also noted loose trash such as plastic bottles, bottle caps, food containers, paper napkins, plastic gloves, crushed cans, etc. The trash was located between tracks, on ballast and on concrete areas at the facility. See examples:

- Housekeeping practices for each section of the facility have been developed by the contractor to address the trash, gloves, bottles and other material on the ground.
- Monthly walks with the area supervisor for each section have been established to observe and address housekeeping issues directly with the supervisor responsible. Inspections will be documented and recorded.
- Rolling stock equipment contractor will be issued Project letter to red tag and remove from service area any broken or damaged hoses.
  - Contractor staff were instructed to inspect hoses in the Service & Inspection Area prior to use, red tag defective equipment and remove from area and only use equipment that is intact.

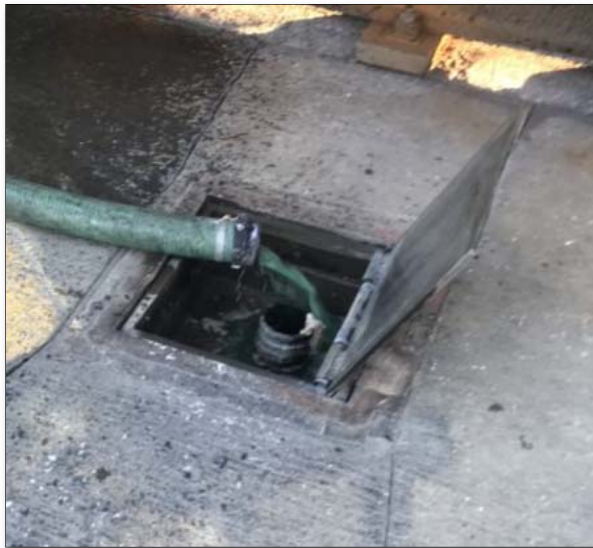
Ex. 16- Improper Connection

Loose Drainage Connection – During operating hours, while trains were being serviced on October 15, 2019, we noted a waste removal hose from a passenger car that was not properly connected to the sewage receptacle. Despite the lack of a secured connection, the train continued to be serviced. Based on discussion with management on October 31, 2019, while a damaged hose was used in Exhibit 16 below, **no contamination occurred since the secondary container catches any overflow from the hose**. Nonetheless, management agreed to the importance of securing the connection between the hose and the sewage receptacle.

Project letter issued to the Rolling stock equipment Contractor in regard to the red tagging and removal of broken/damaged hoses from area of service to be issued by November 30, 2019 (pending Internal Audit verification).
