Appendix E. Simi Valley Double Track and Platform Project Jurisdictional Delineation Report

Jurisdictional Delineation Report

*Simi Valley Double Track and Platform
Project*

February 2021

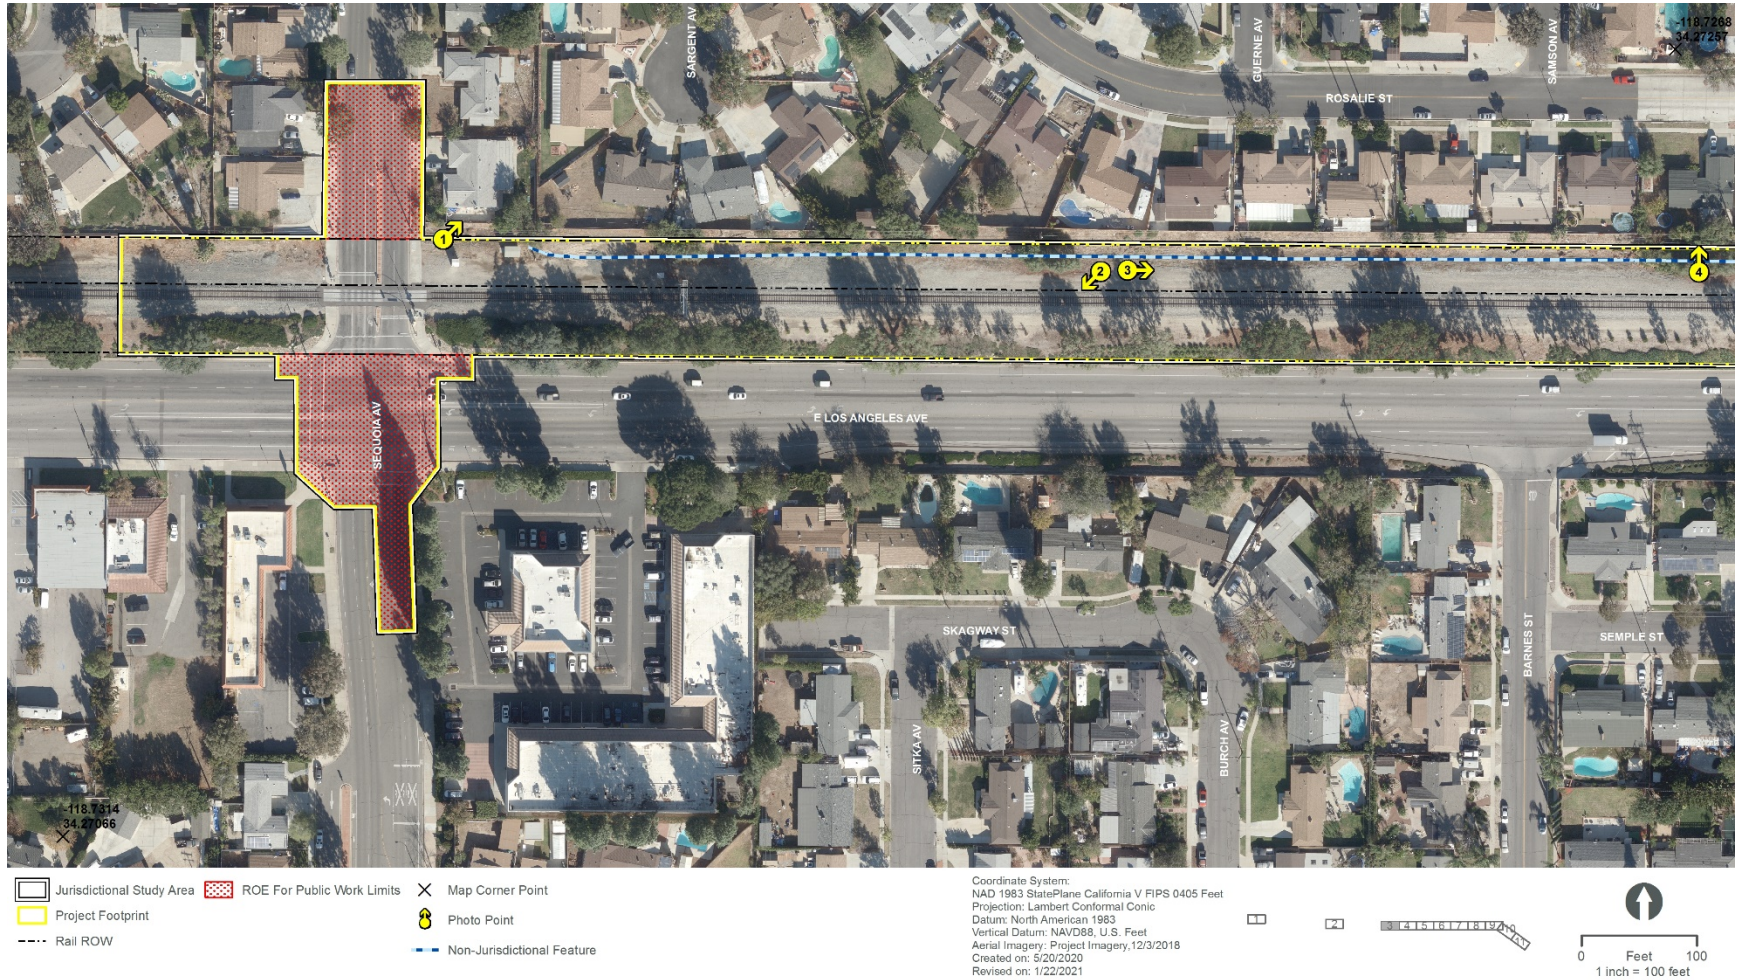
Figure 5-4. Jurisdictional Delineation Map
 (Sheet 3 of 11)

Isolated, standing water was observed at one storm drain outlet (Figure 5-5, Sheet 3, and Appendix A, Photograph 4). The area at the outlet contains southern cattail (*Typha domingensis*, obligate species), dallis grass (*Paspalum dilatatum*, facultative species), Washington fan palm (*Washingtonia robusta*, facultative wetland [FACW]), and ornamental fig (*Ficus* sp., upland species). Based on the presence of mucky soils, this outlet supports approximately 36 square feet of wetland. However the outlet drains only adjacent residential development and long duration inundation is most likely a result of over-irrigation.

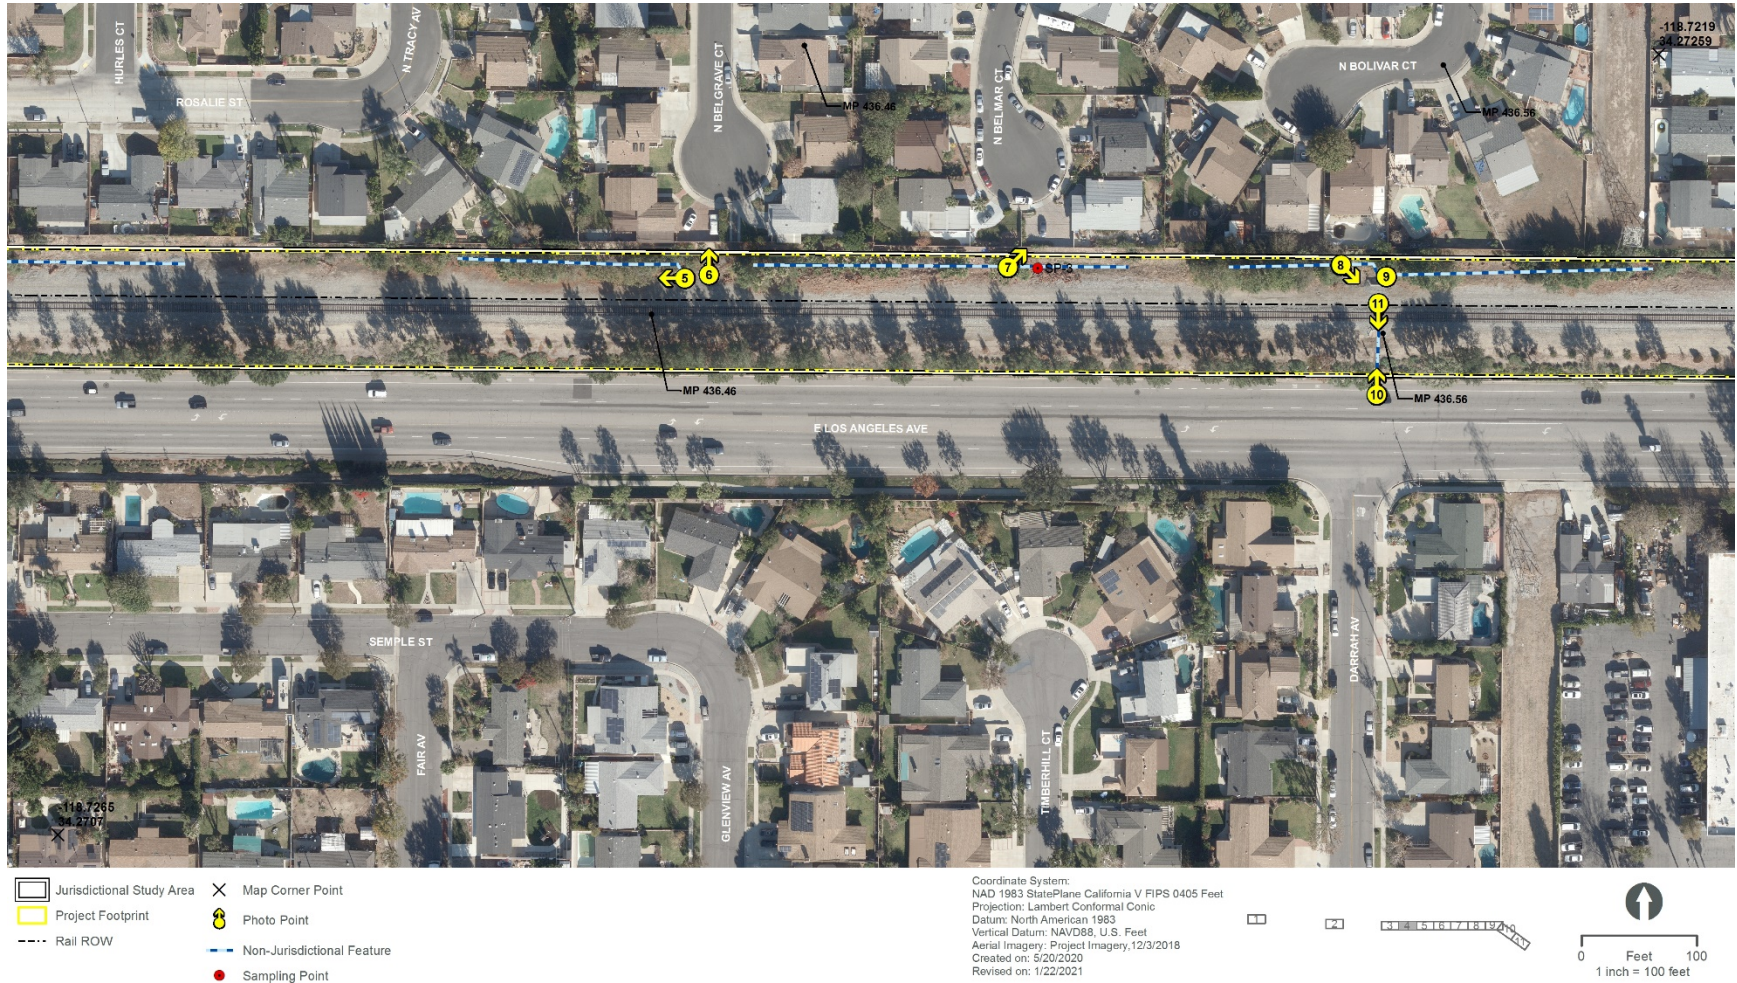
Figure 5-4. Jurisdictional Delineation Map
 (Sheet 4 of 11)

As depicted on Figure 5-5 (Sheets 3 and 4) and Appendix A (Photographs 3 and 7), an intermittent series of swales occur along the northern edge of the ROW between Sequoia Avenue and approximately 230 feet east of the culvert at MP 436.56. These low areas likely retain surface runoff from the adjacent residential community, which is discharged to the site through a series of short storm drains and wall scuppers. As visible in Appendix A (Photographs 5 through 11), indicators of OHWM, including change in soil characteristics, presence of litter and debris, destruction of terrestrial vegetation, ripples, sediment deposition and flow lines were not observed even though the site visit was made within two weeks after a significant rain event and during an average rain year. A soil pit in one of these typical swales that exhibited 100-percent cover of curly dock (*Rumex crispus*, facultative species⁴) exhibited no hydric soil indicators or indicators of wetland hydrology (Appendix A, Photograph 7, and Appendix B, Wetland Determination Data Form - Sampling Point 3).

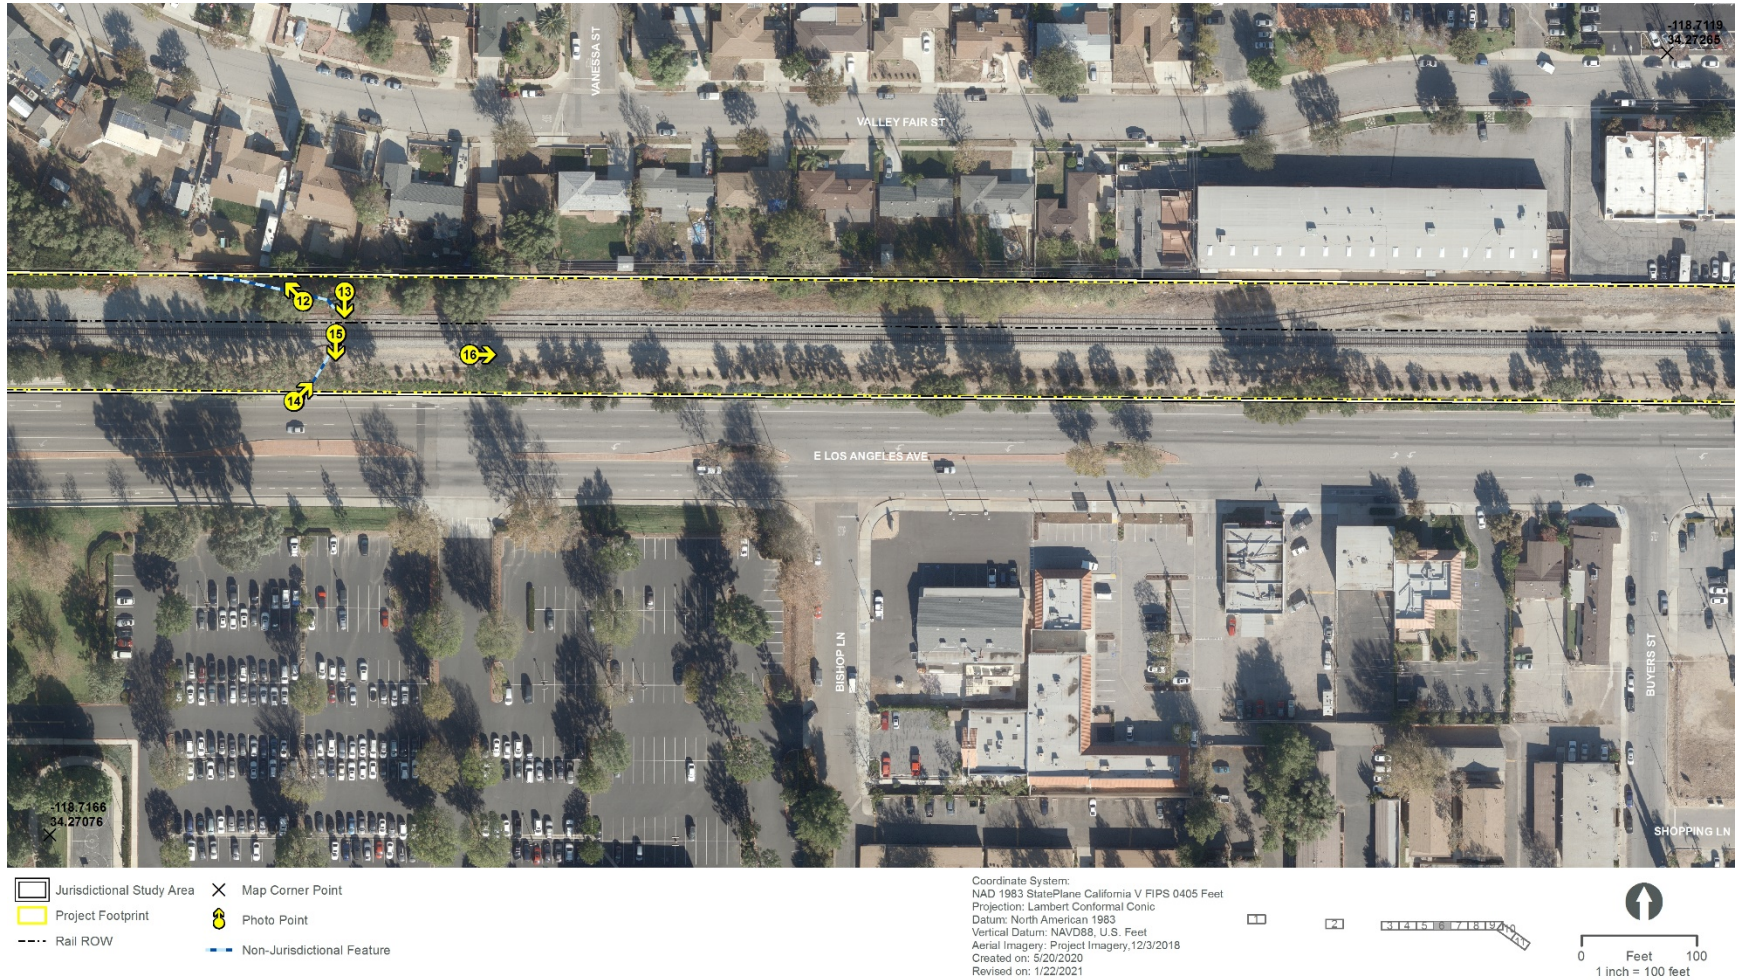
Figure 5-4. Jurisdictional Delineation Map
 (Sheet 6 of 11)

Similarly, as depicted on Figure 5-5 (Sheet 6) and Appendix A (Photographs 12 through 15), the culvert at MP 436.96 exhibited no indicators of an OHWM entering the culvert and only signs of 6-inch wide sheet flow extending south of the outlet.

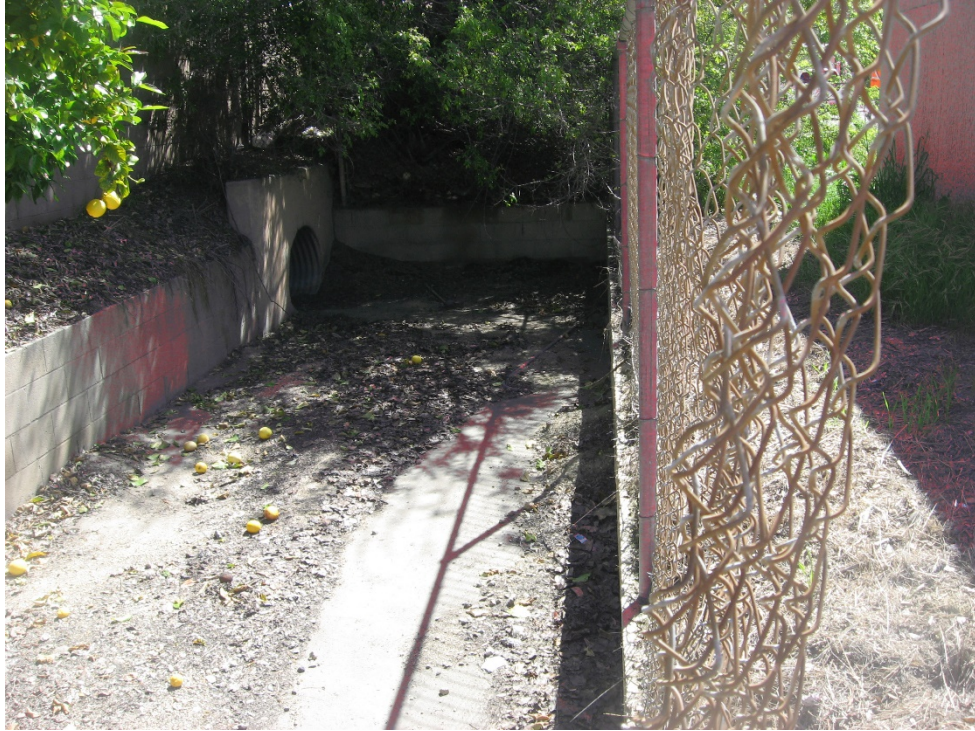
Photograph 1: Off-Site Ditch Constructed in Uplands looking northeast. Ditch drains residential neighborhood to north of Project (4/21/2020).

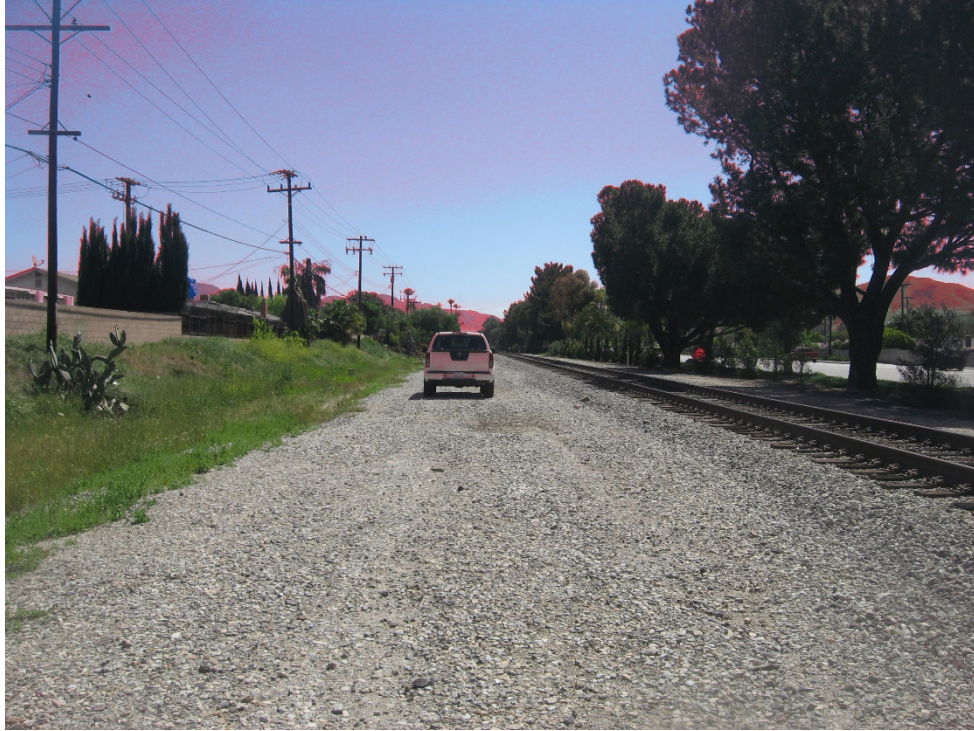
Photograph 2: Existing rail line looking southwest towards the intersections of Sequoia Avenue and Los Angeles Avenue (4/21/2020).

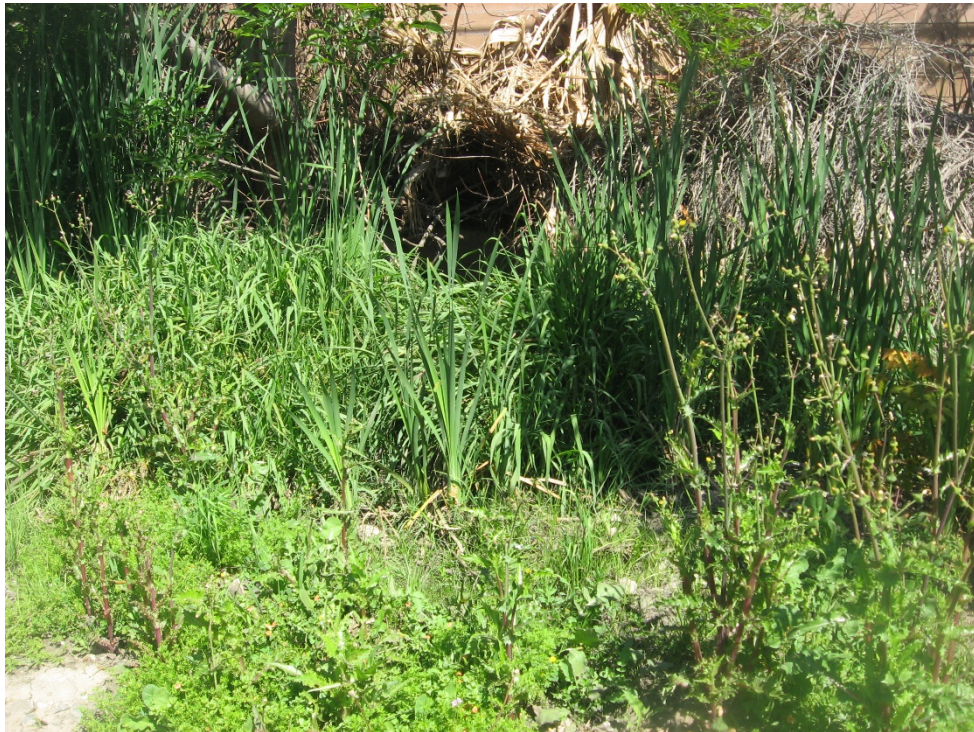
Photograph 4: Standing water observed at storm drain outlet. Vegetated with cattail (*Typha domingensis*, OBL), dallis grass (*Paspalum dilatatum*, FAC) and ornamental (*Ficus* sp.). Culvert drains abutting residential development (4/21/2020).

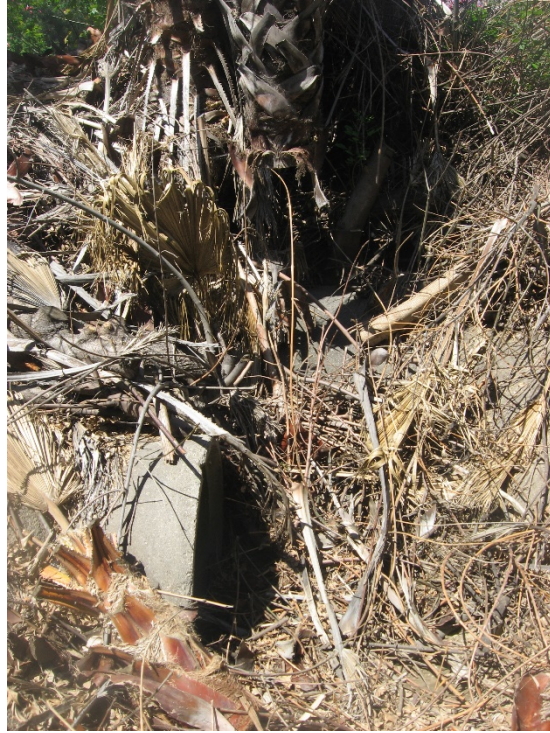
Photograph 5: 24-inch Culvert passing beneath the rail. No OHWM, bed or bank present (4/21/2020).

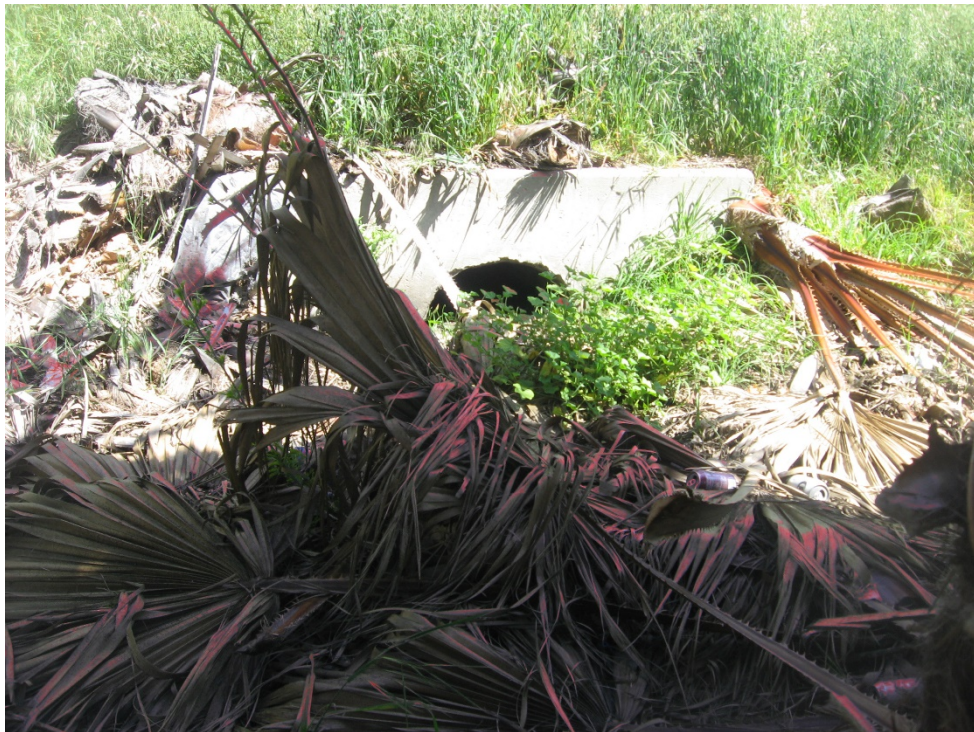
Photograph 6: Culvert outlet from residential neighborhood to the north. No OHWM, bed or bank present (4/21/2020).

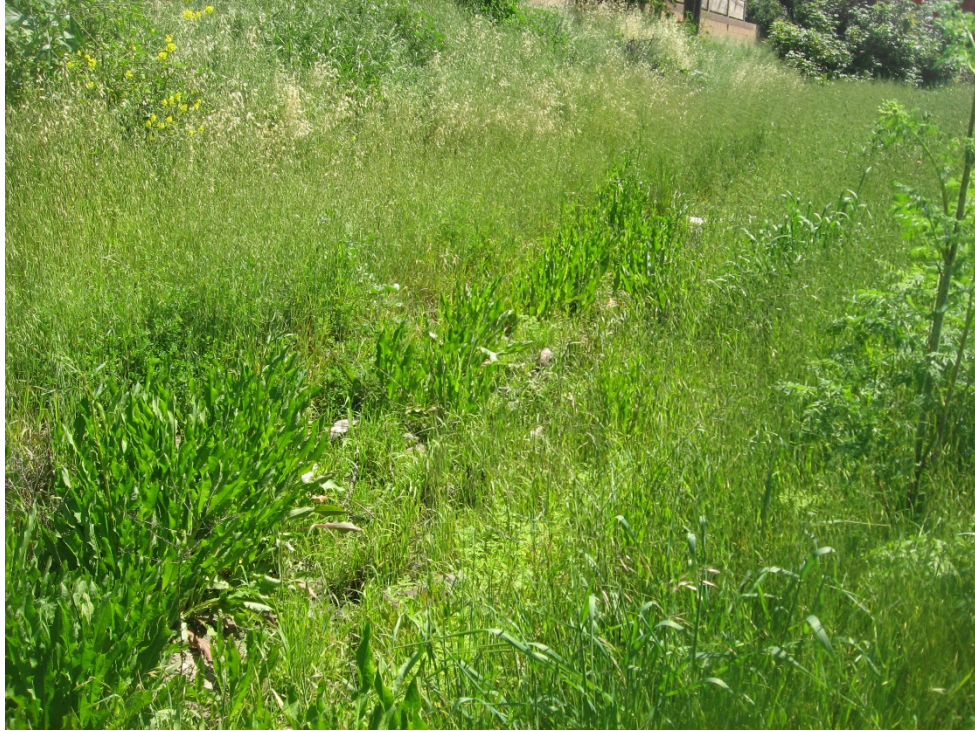
Photograph 7: Soil Pit 3. Swale vegetated with curly dock (*Rumex crispus*). No indicators of wetland hydrology or hydric soils, no OHWM, bed or bank present (4/21/2020).

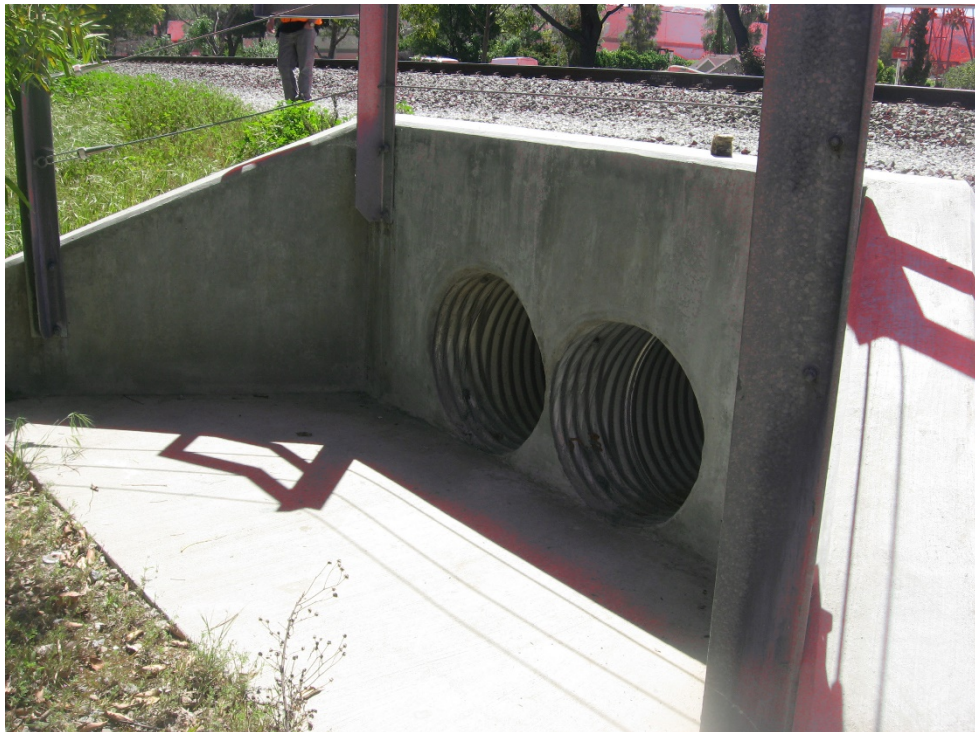
Photograph 8: Inlet of existing double culvert MP 436.56 passing beneath the rail looking southeast. No OHWM, bed or bank present. Based on historic topographic maps, this location did not support a defined drainage (4/21/2020).

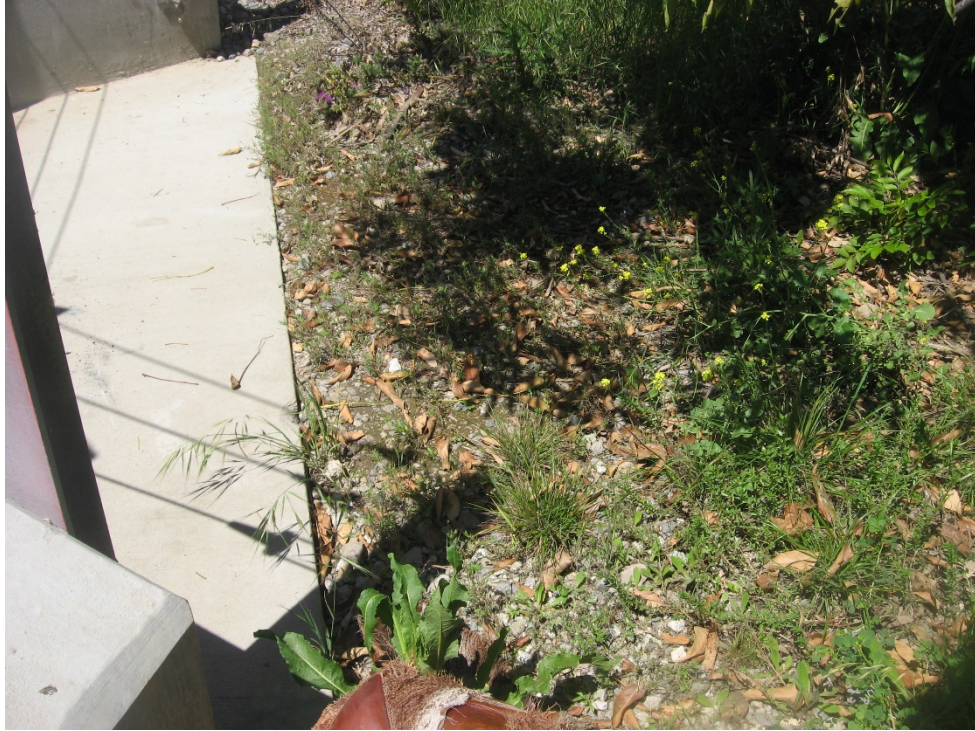
Photograph 9: Close-up view of culvert MP 436.56 inlet. No OHWM, bed or bank present (4/21/2020).

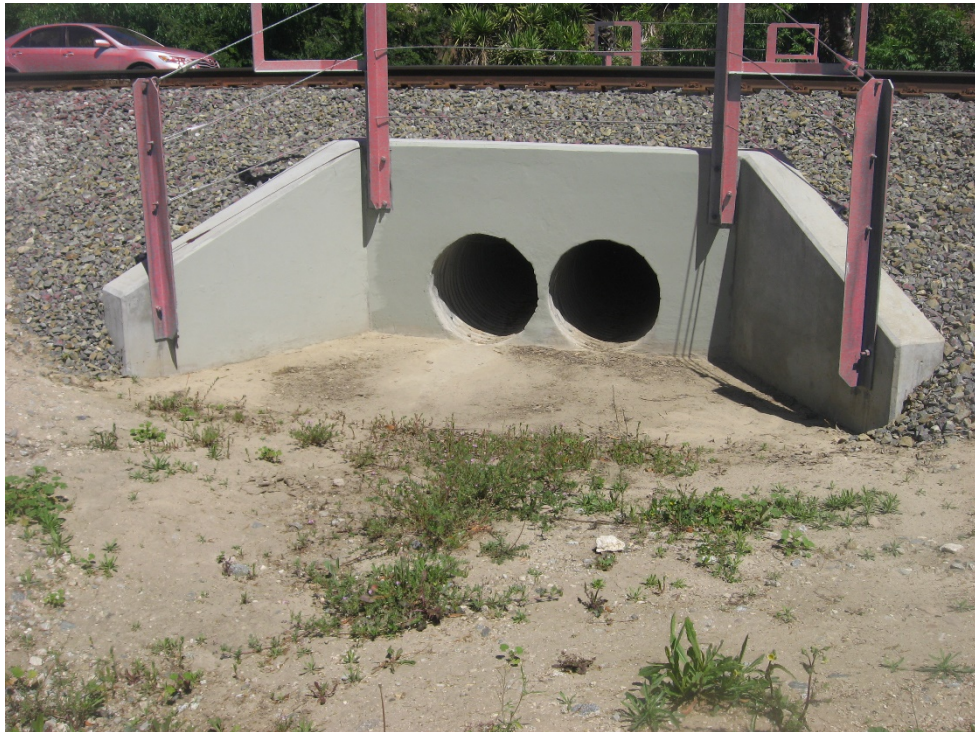
Photograph 10: Outlet of existing double culvert MP 436.56 passing beneath the rail looking north. No OHWM, bed or bank present (4/21/2020).

Very fine sediment was observed on the concrete apron of the outlet of the culvert at MP 436.56 (Appendix A, Photograph 10), however based on the topography at the outlet and the absence of indicators at the culvert inlet (Appendix A, Photographs 8 and 9), the sediment appears to be deposited by local sheet flow collecting on the apron rather than storm flows from higher in the watershed. Based on aerial photography and USGS topographic mapping from 1947 through 1977 (Historic Aerials 2020) both the culvert MP 436.46 and the culvert at MP 436.56 may have historically passed irrigation drainage southward from the adjacent agricultural uses to the north. Since that time, urban development has resulted in the diversion of surface flows to underground storm drain systems, the culvert at MP 436.46 was abandoned and only local sheet flow from Rosalie Street, Belmar, Belgrave and Bolivar Courts, and Cadman Street appear to still be discharged to the railroad ROW where it infiltrates the soil.

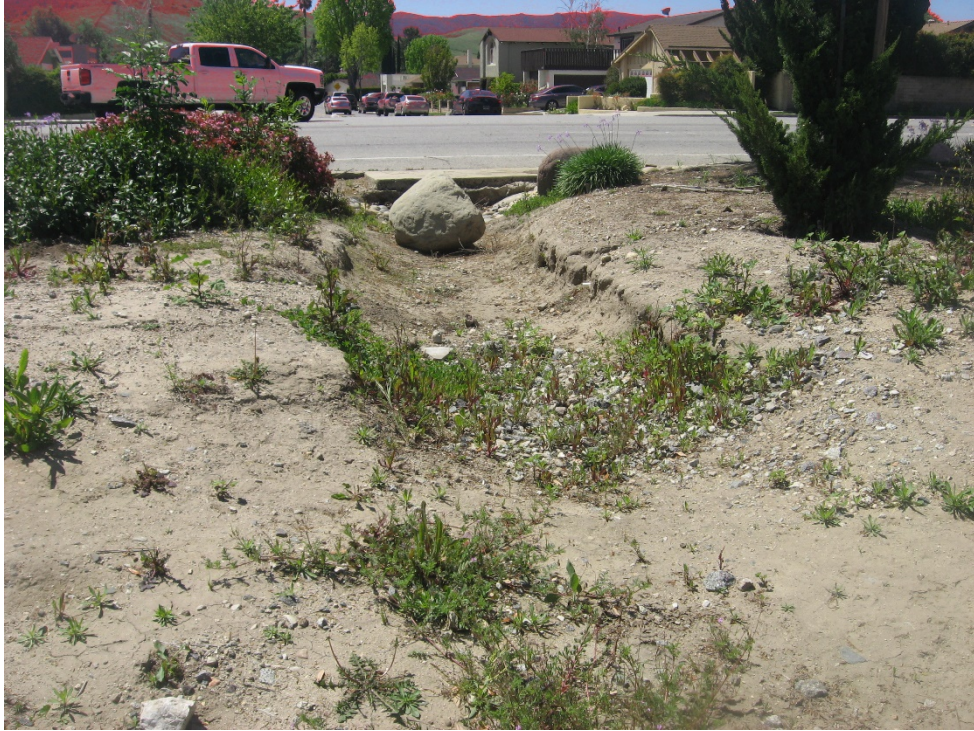
Photograph 11: Swale leading from culvert MP 436.56 to storm drain inlet at Los Angeles Ave. No OHWM. Slight historic incision visible for approximately 5 feet (4/21/2020).

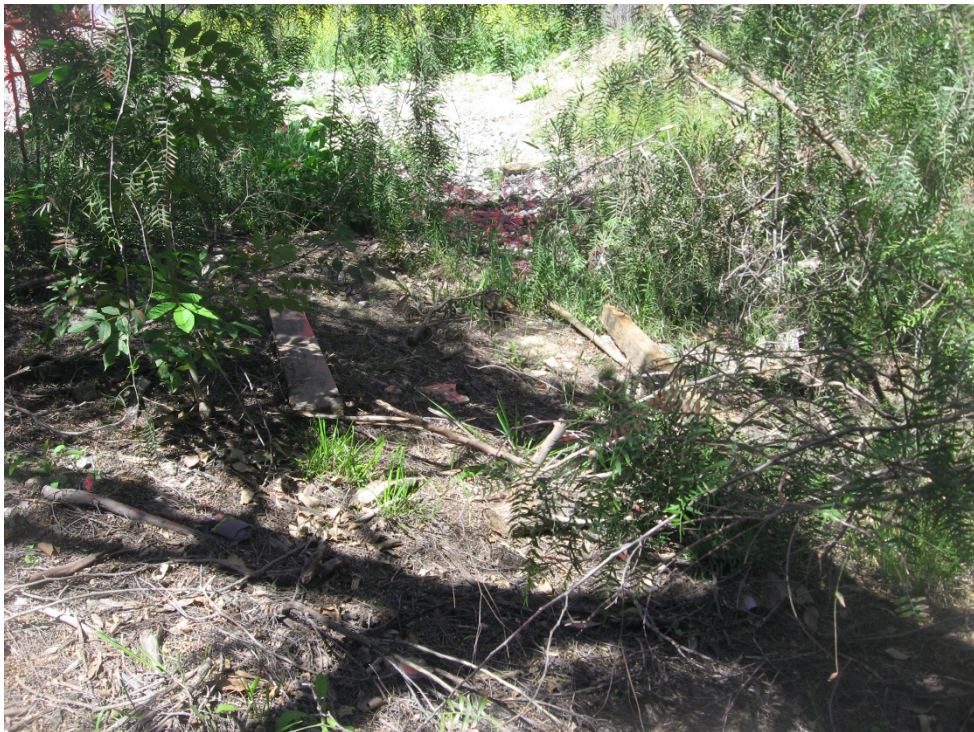
Photograph 12: Existing culvert MP 436.96 passing beneath rail looking upslope (northwest). No OHWM, bed or bank present (4/21/2020).

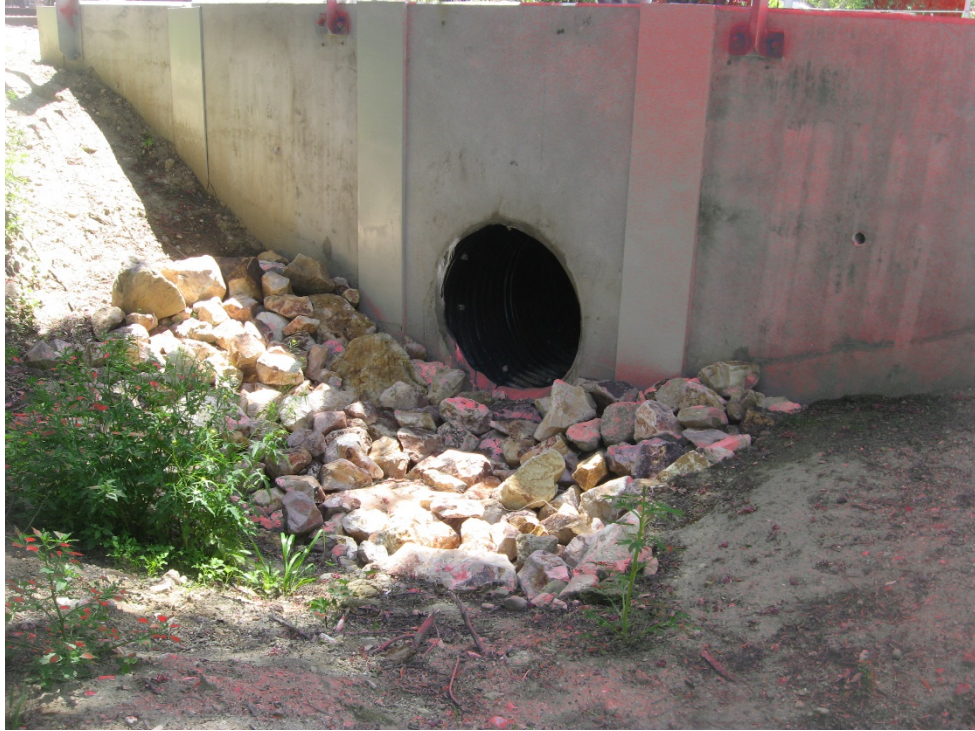
Photograph 13: Inlet of existing culvert MP 436.96 passing beneath the rail looking south. No OHWM, bed or bank present. Based on historic topographic maps, this location did not support a defined drainage (4/21/2020).

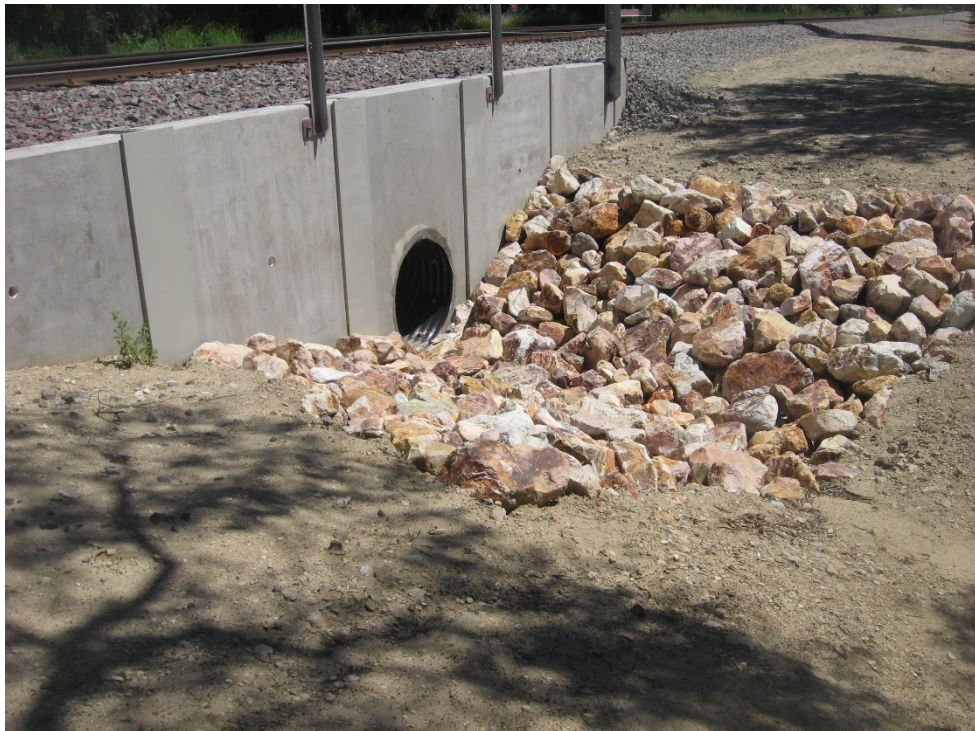
Photograph 14: Outlet of existing culvert MP 436.96 passing beneath the rail looking northeast. No OHWM, bed or bank present (4/21/2020).

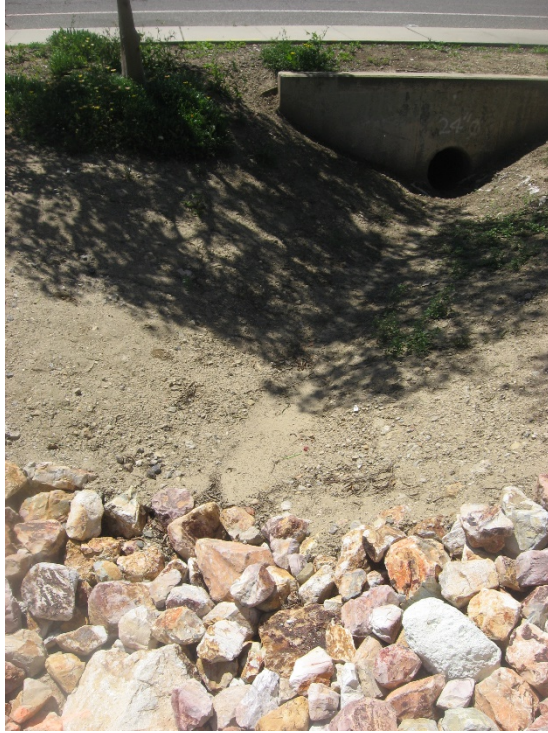
Photograph 15: Swale leading from culvert MP 436.96 to storm drain inlet at Los Angeles Avenue. No OHWM, bed or bank (4/21/2020).

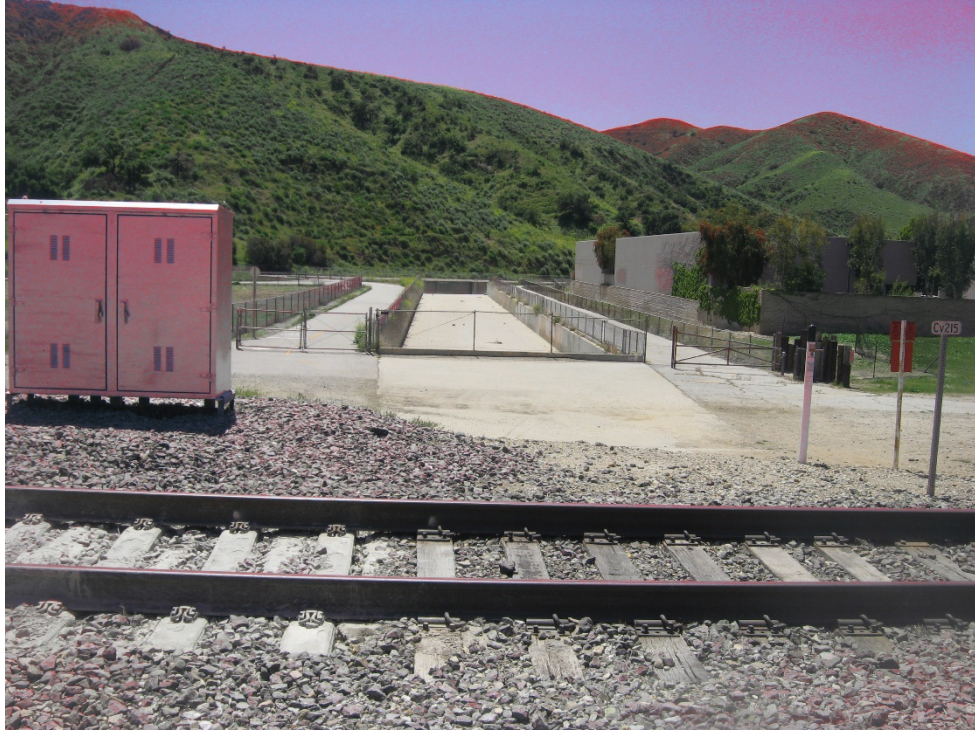
The only jurisdictional aquatic resources located within the immediate vicinity of the JSA are Arroyo Simi, which is located just outside of the JSA (Appendix A, Photograph 20), and Las Lajas Canyon channel, which is tributary to Arroyo Simi and passes beneath the rail ROW and East Los Angeles Avenue via a concrete box culvert (Appendix A, Photograph 17).

Photograph 16: Rail Right-of-Way looking east (4/21/2020).

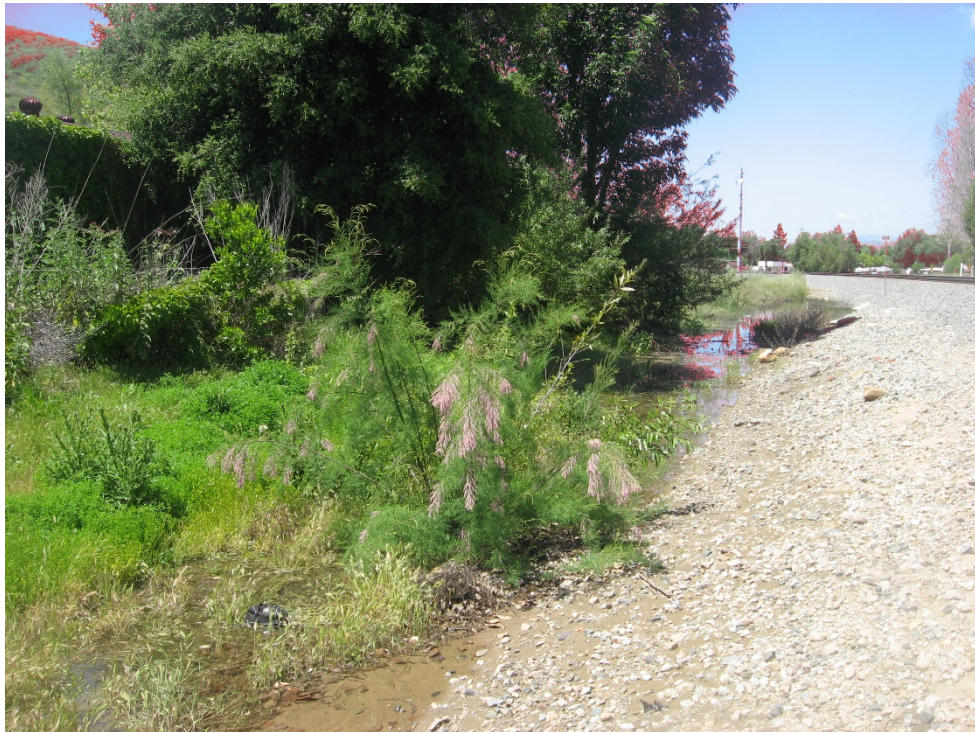
Photograph 18: Sampling Point 1, shallow depression south of the rail at the station. Based on the mix of recently recruited hydrophytic vegetation and upland herbs, this inundation appears recent and may indicate drainage is blocked (4/21/2020).

A relatively large ponded area was observed near the Simi Valley Station, south of the railroad and west of the existing station platform. The depression remained inundated for approximately 4 weeks but exhibited little vegetative cover. Where vegetation was present, it consisted of dead upland bromes or newly recruited hydrophytes. Hydric soil indicators were not present, suggesting that the ponding may not reflect normal circumstances and would no longer occur following regular maintenance activities (Appendix A, Photograph 18, and Appendix B, Wetland Determination Data Form – Sampling Point 1). Standing water was also observed east of the Hidden Ranch Drive crossing and south of the rail at a small culvert passing beneath the Hidden Ranch Drive parallel to the rail. Although the depression supported a predominance of hydrophytes, it did not exhibit hydric soils (Appendix A, Photograph 19, and Appendix B, Wetland Determination Data Form – Sampling Point [i.e., soil pit] 2). Figure 5-5 depicts all features investigated within the JSA. Representative photographs are provided in Appendix A. Wetland Determination Data Forms are provided in Appendix B.

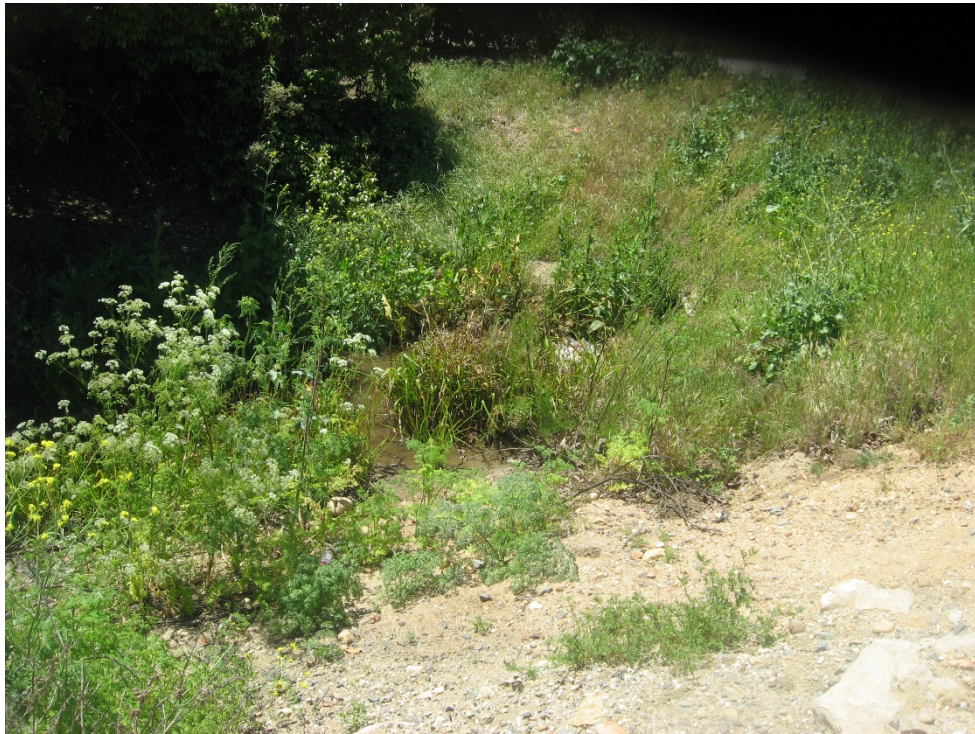
Photograph 19: Sampling Point 2, shallow depression at rail crossing east of station (4/21/2020).
